**Draft Technical Memorandum**

**Orofino Asbestos Site**

**Vegetative Cover Performance Evaluation**

**April 14, 2014**

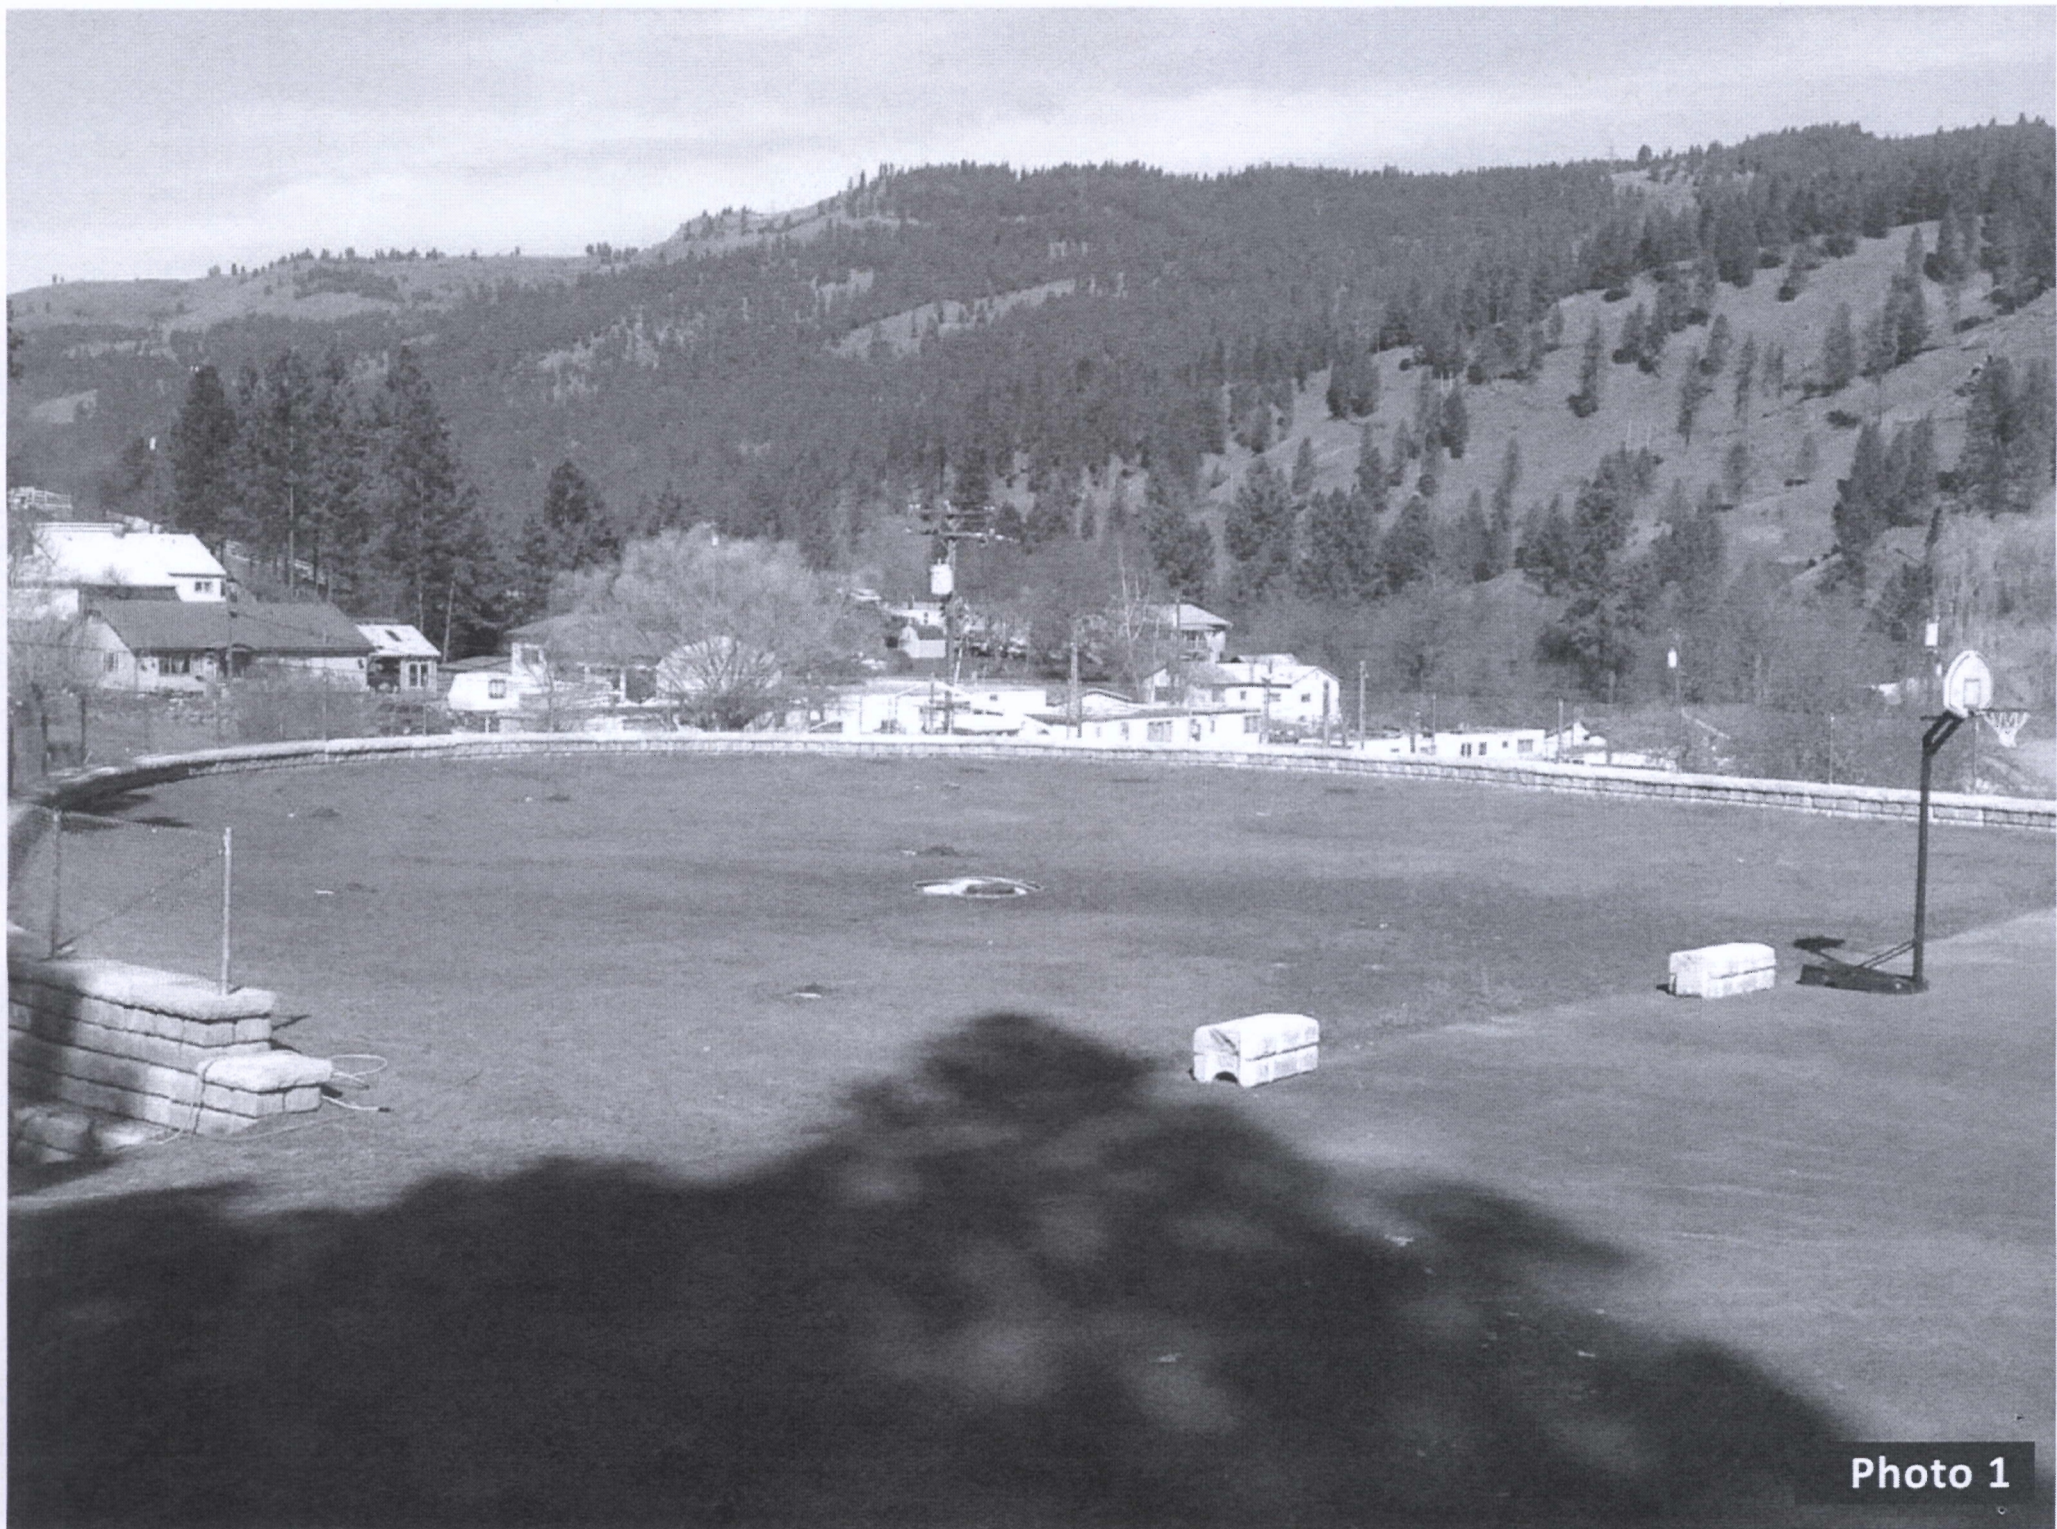
Photo 1

During the March 21, 2014 site visit, after making initial visual observations, we established a 9-point grid (3 x 3) across the area of the soil cover. At each grid point we dug a small test hole with a spoon or trowel to assess soil depth and characteristics at each grid point. The location of each grid points is visible as a small pile of soil with a blue sampling glove in Photo 1. Grid points are depicted schematically in Figure 1.

- During the March 21 site visit, there was no standing water on the soil cover area (see Photo 1), although the soil was found to be saturated at the surface and at depth locally. On March 21, soil moisture content varied by location, with slightly more than half of the area having saturated conditions below the immediate surface.

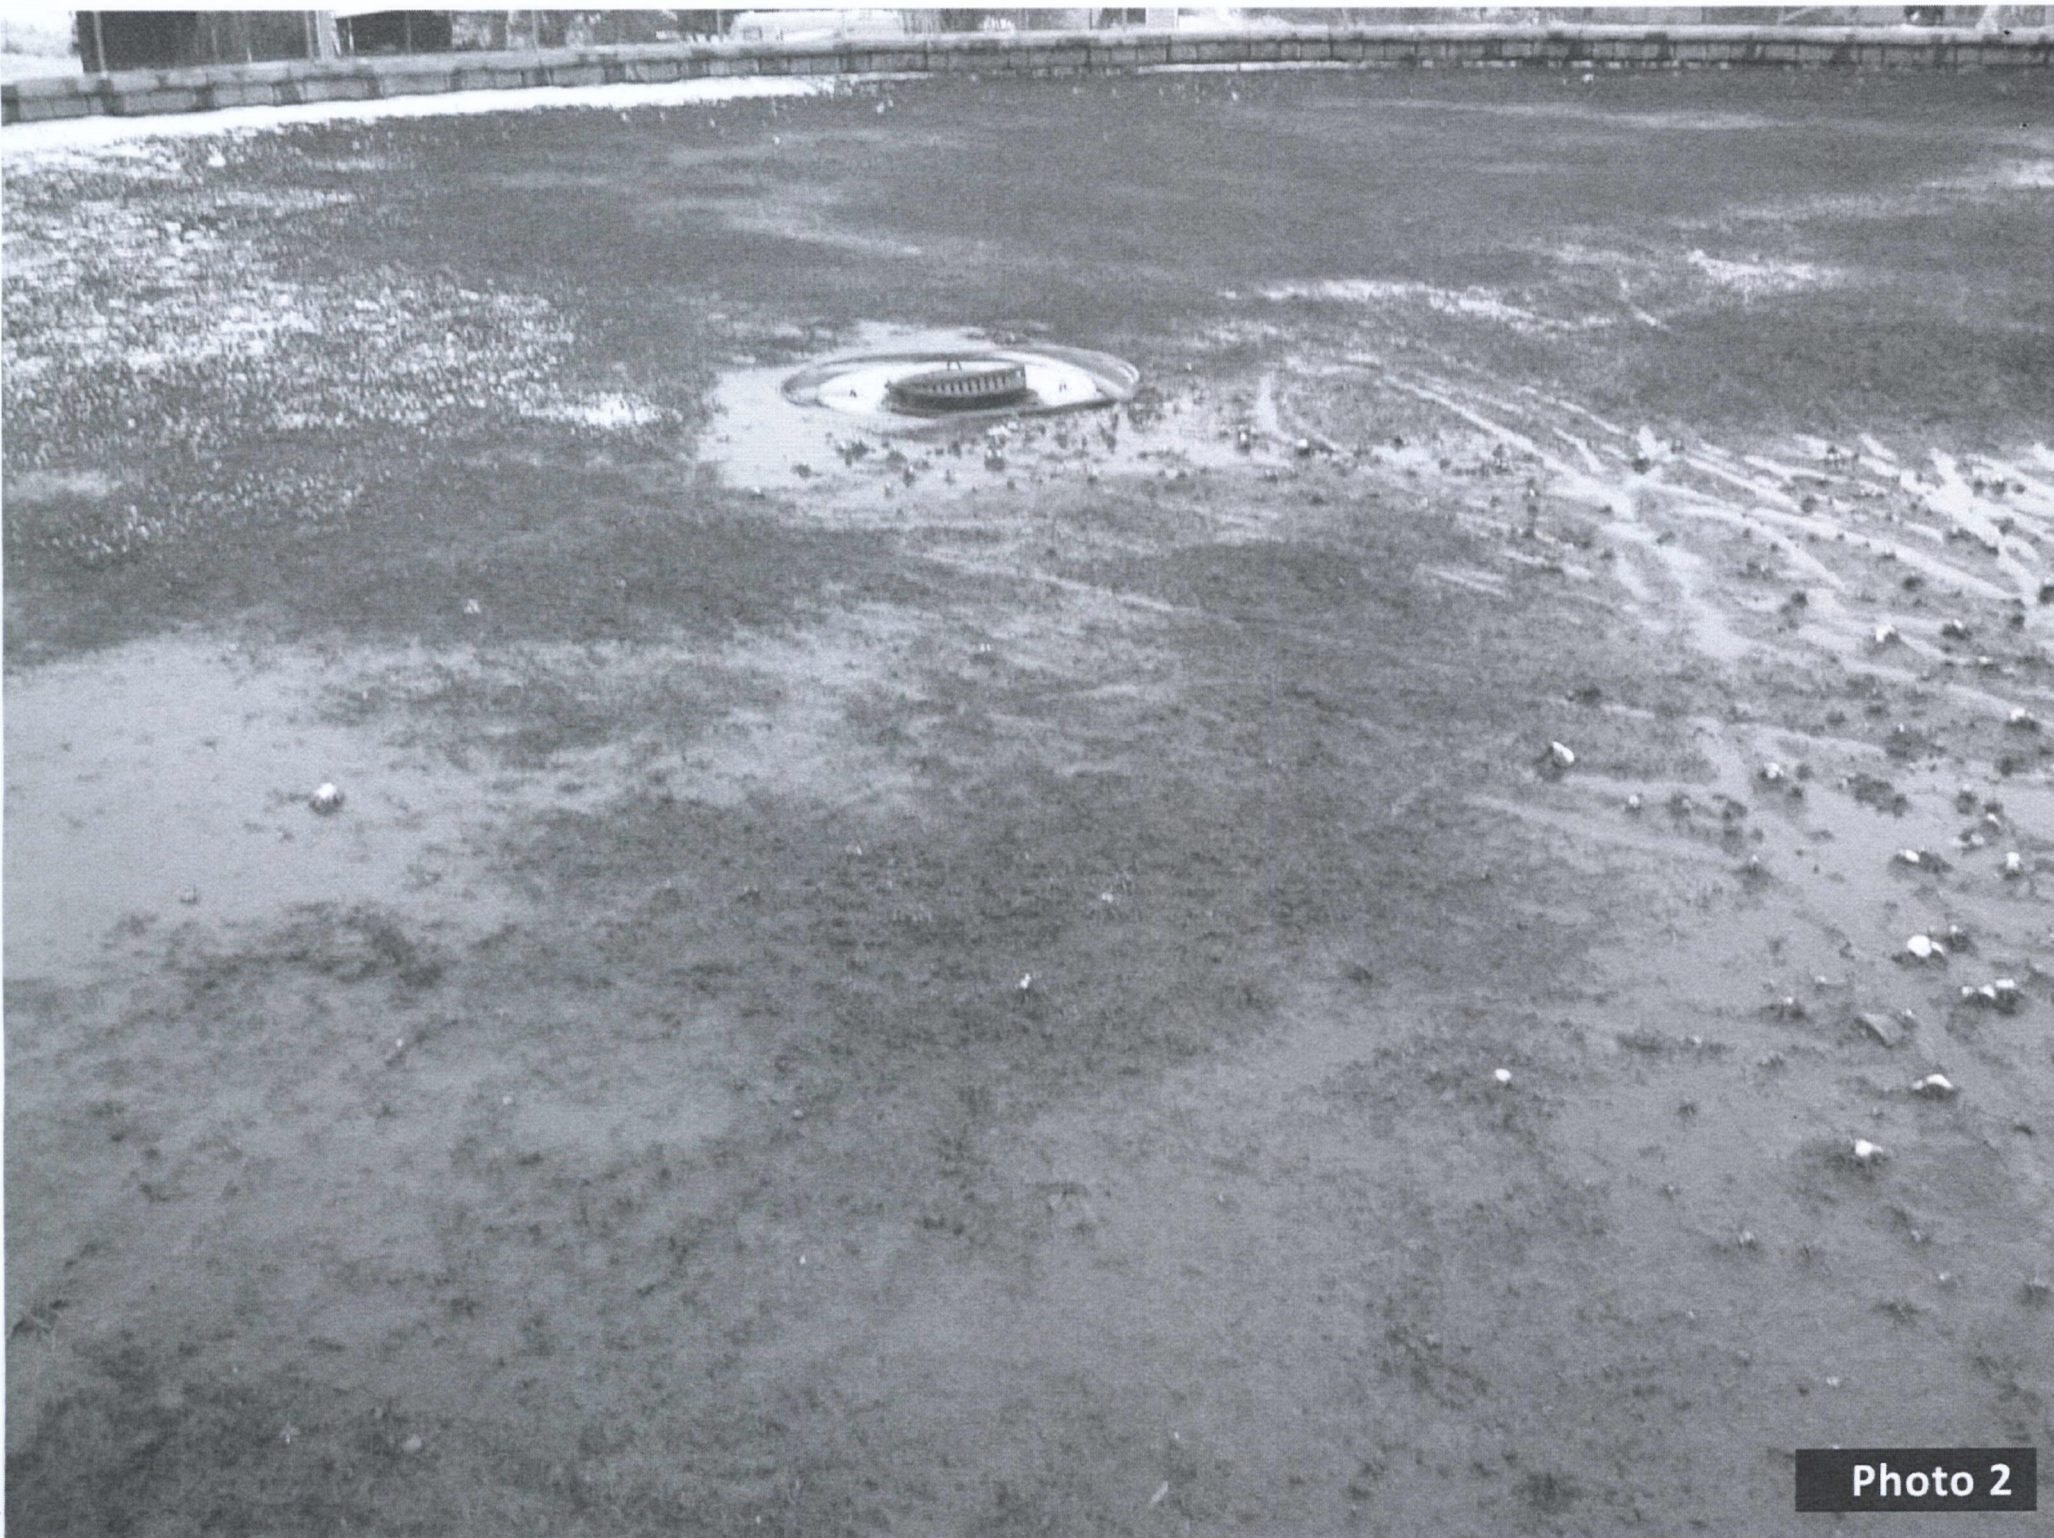
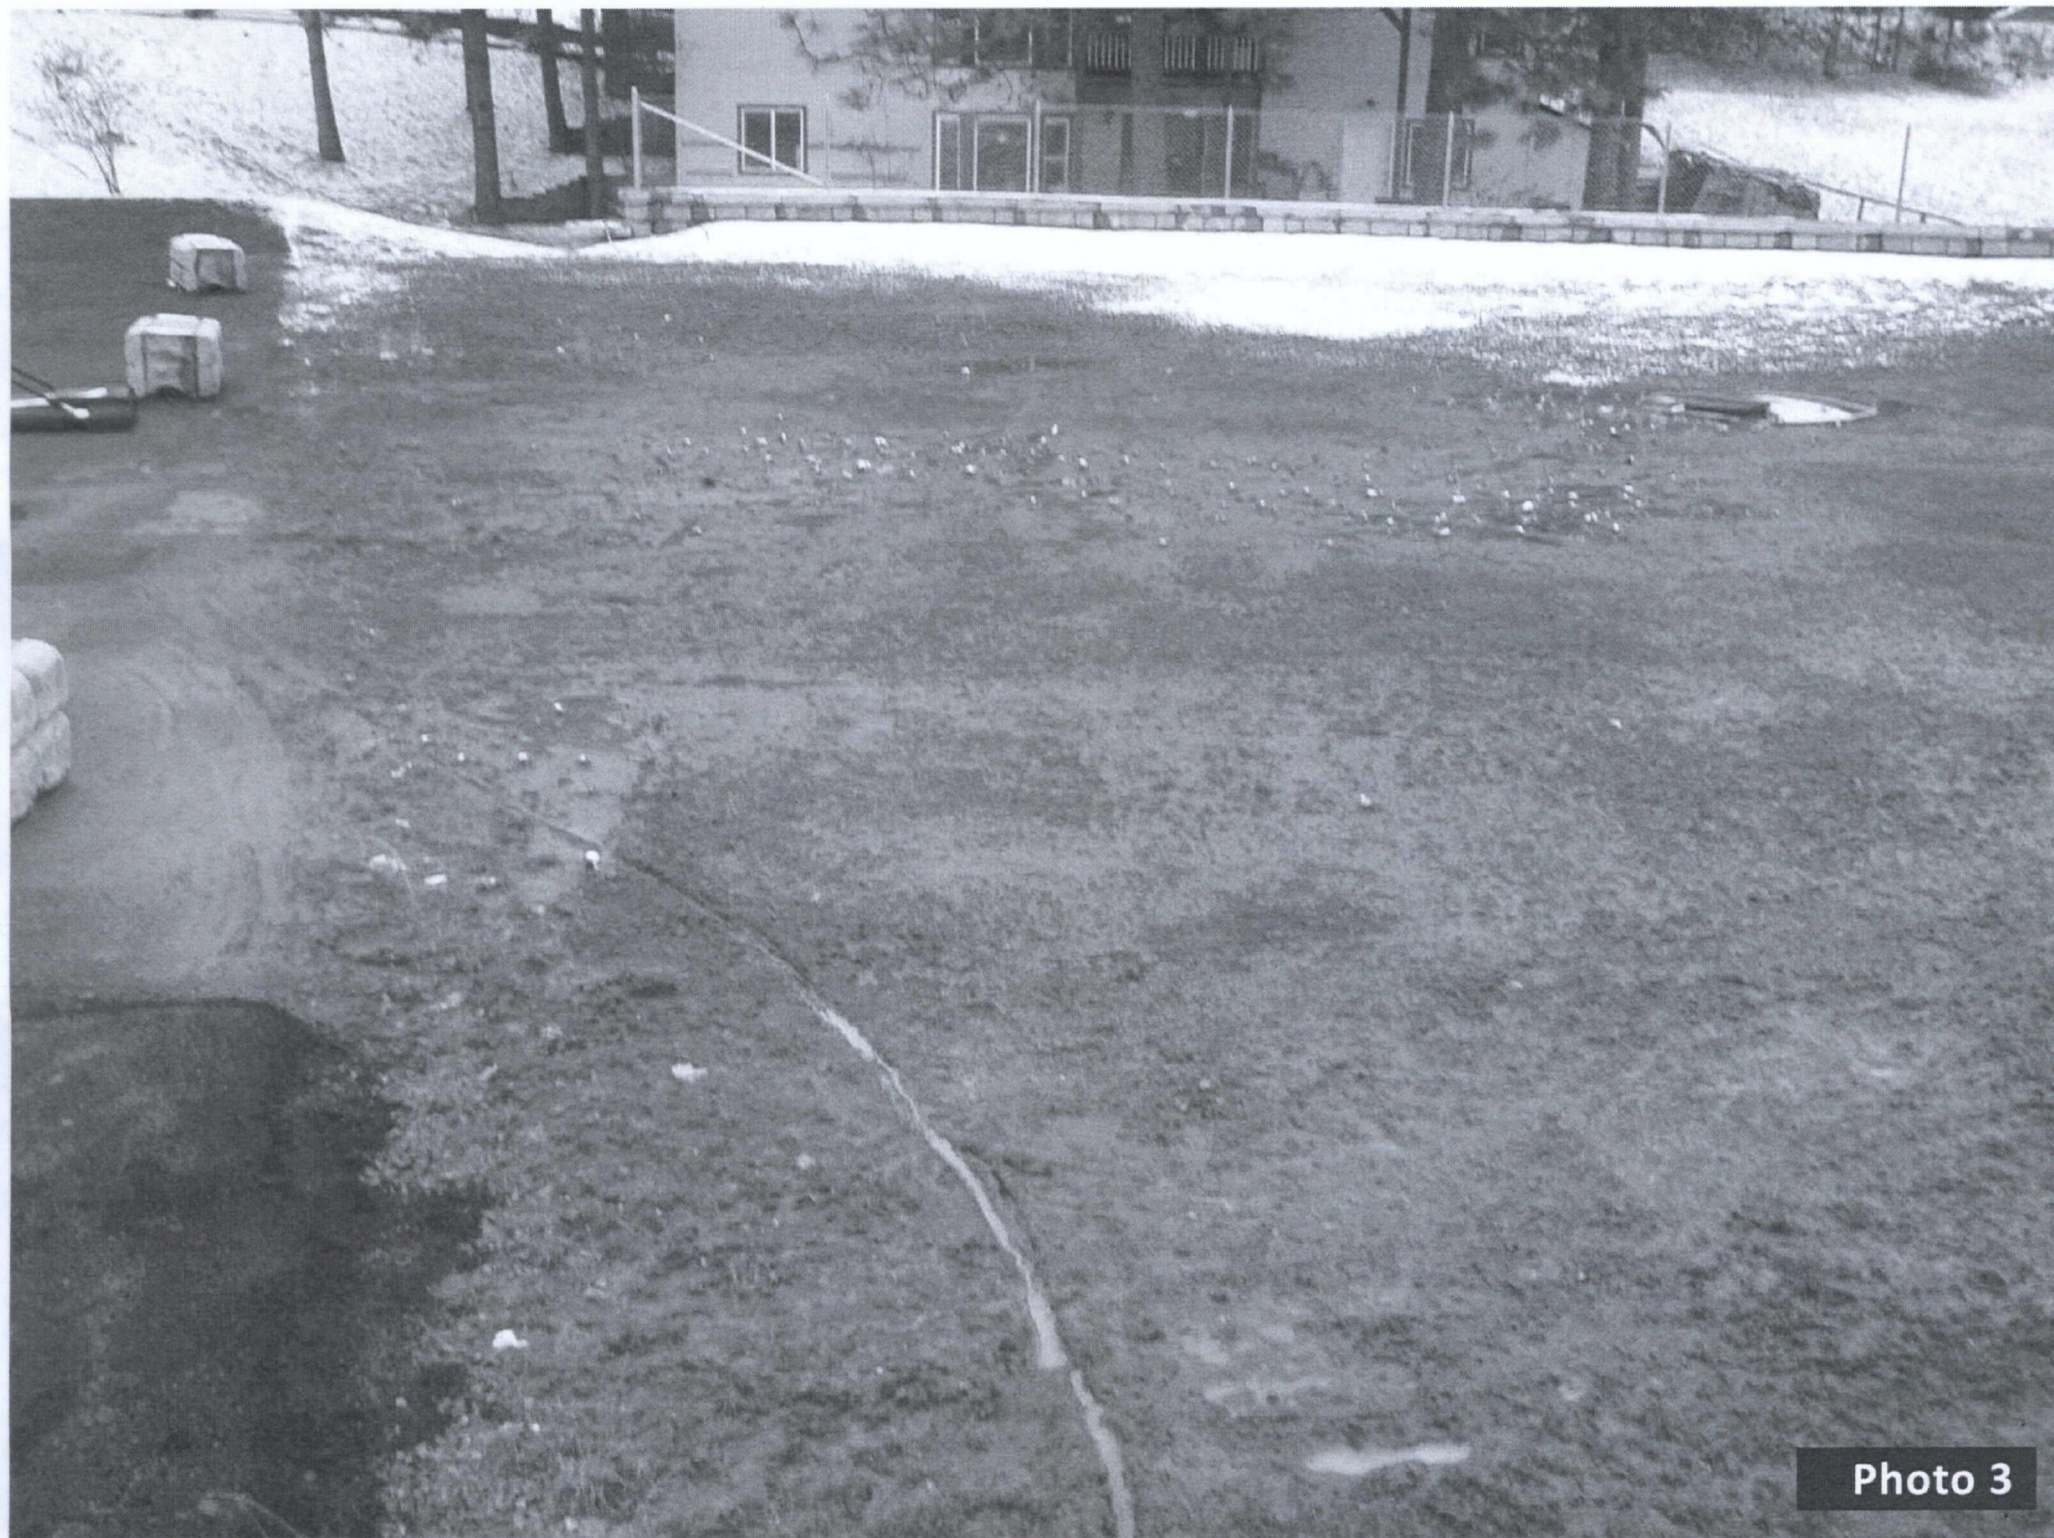
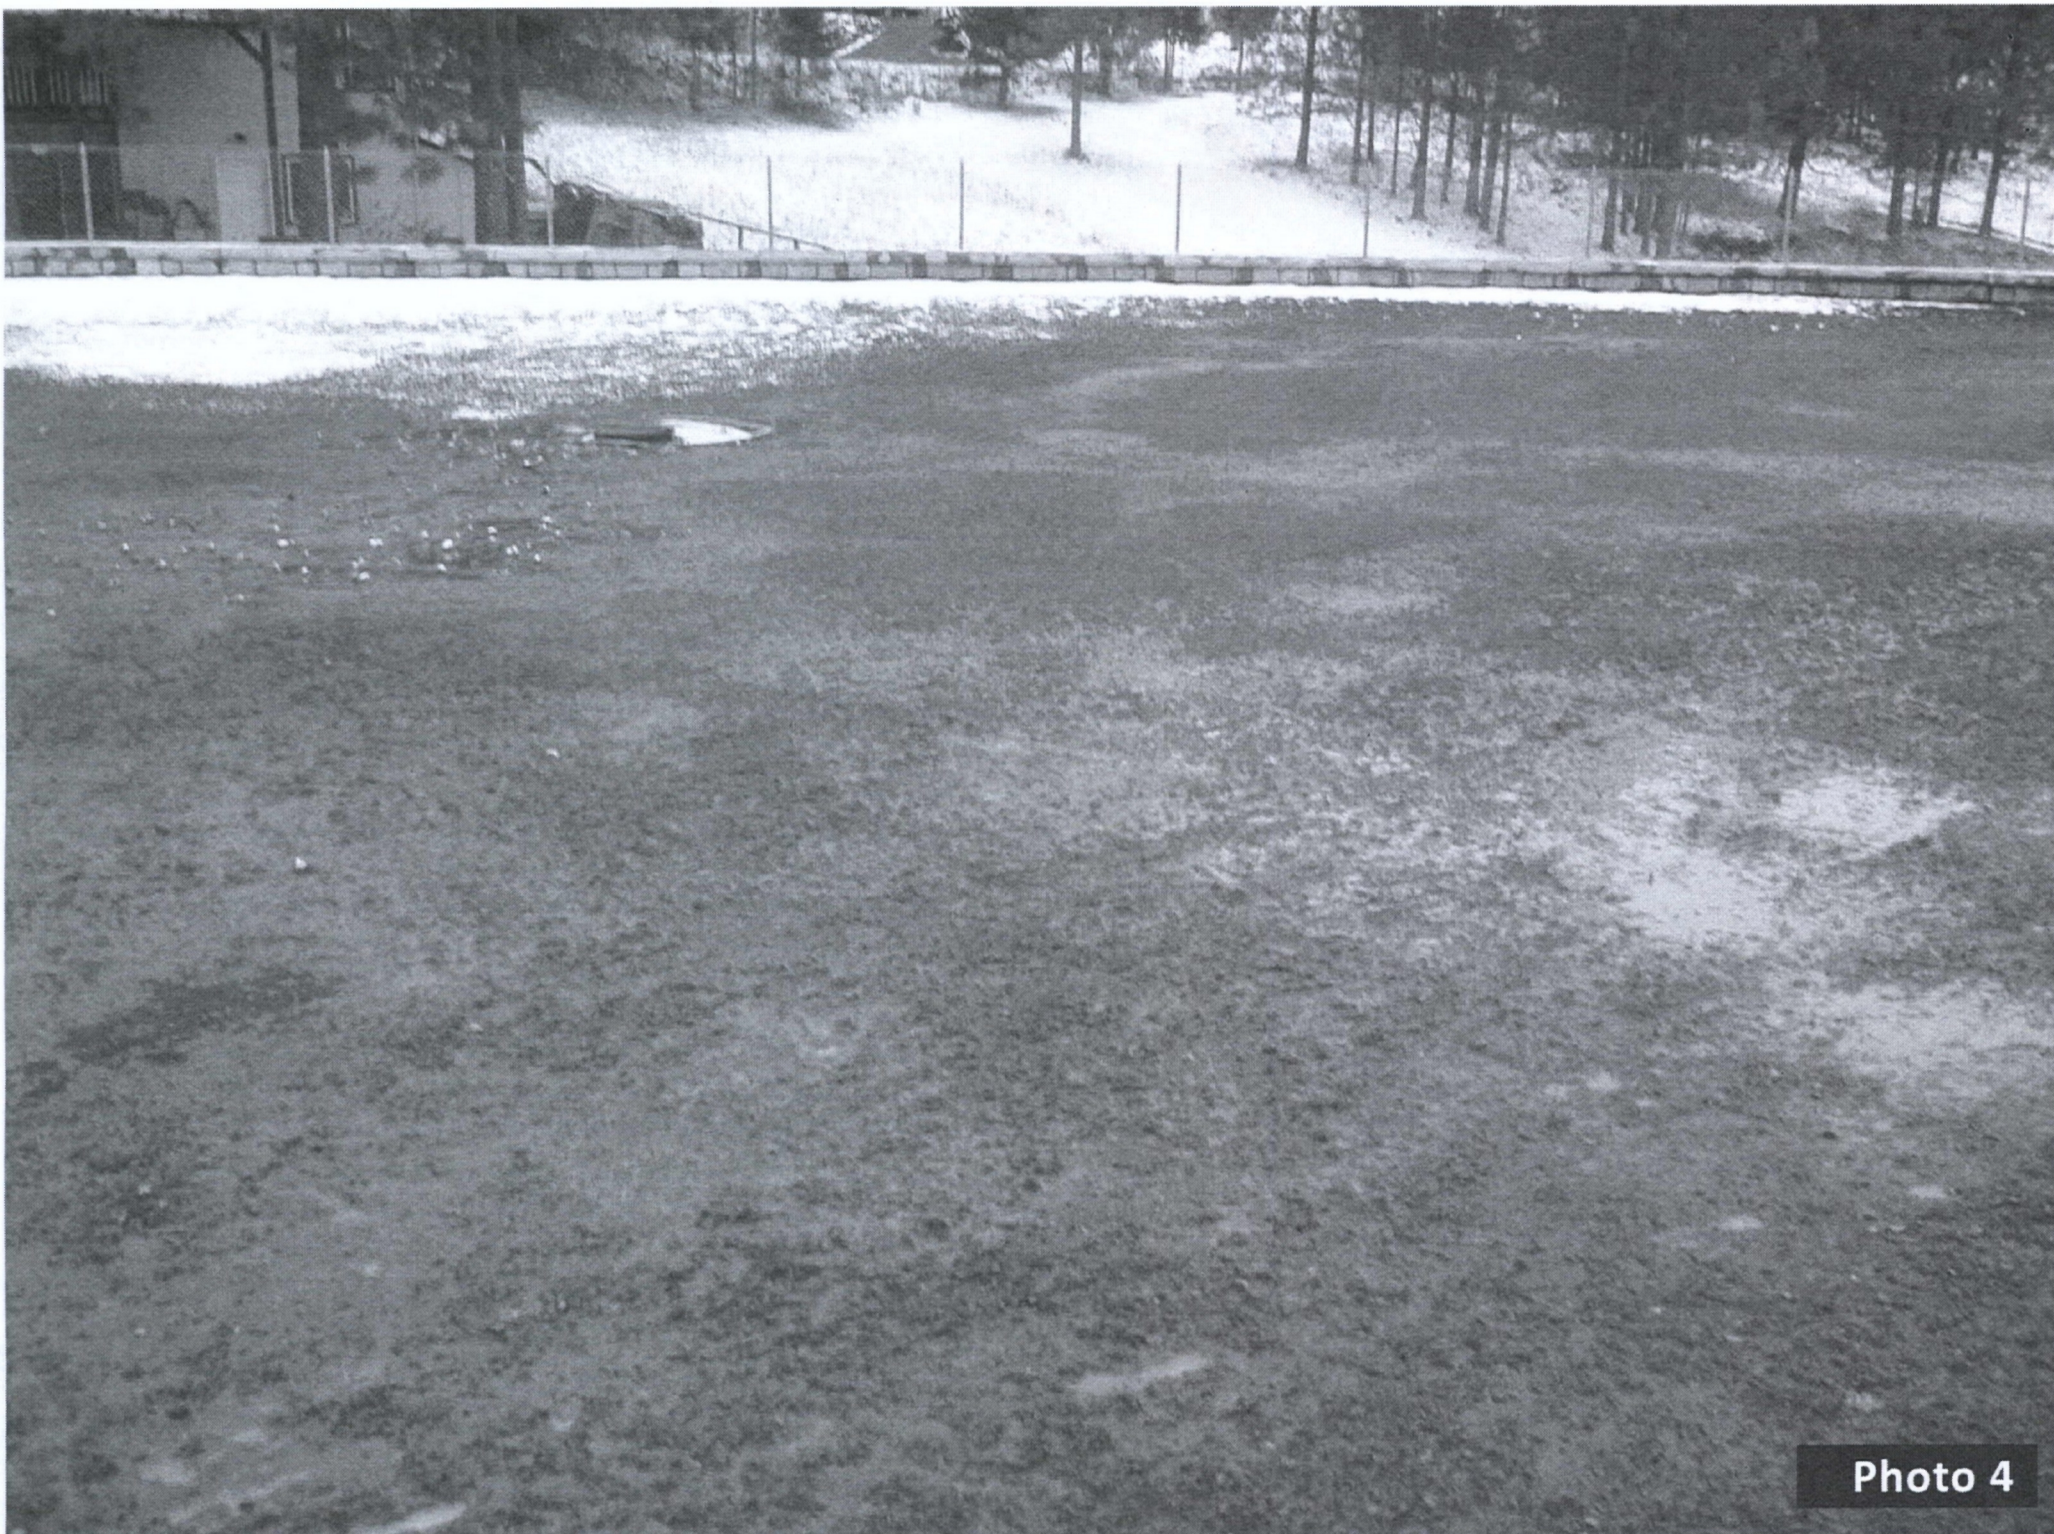
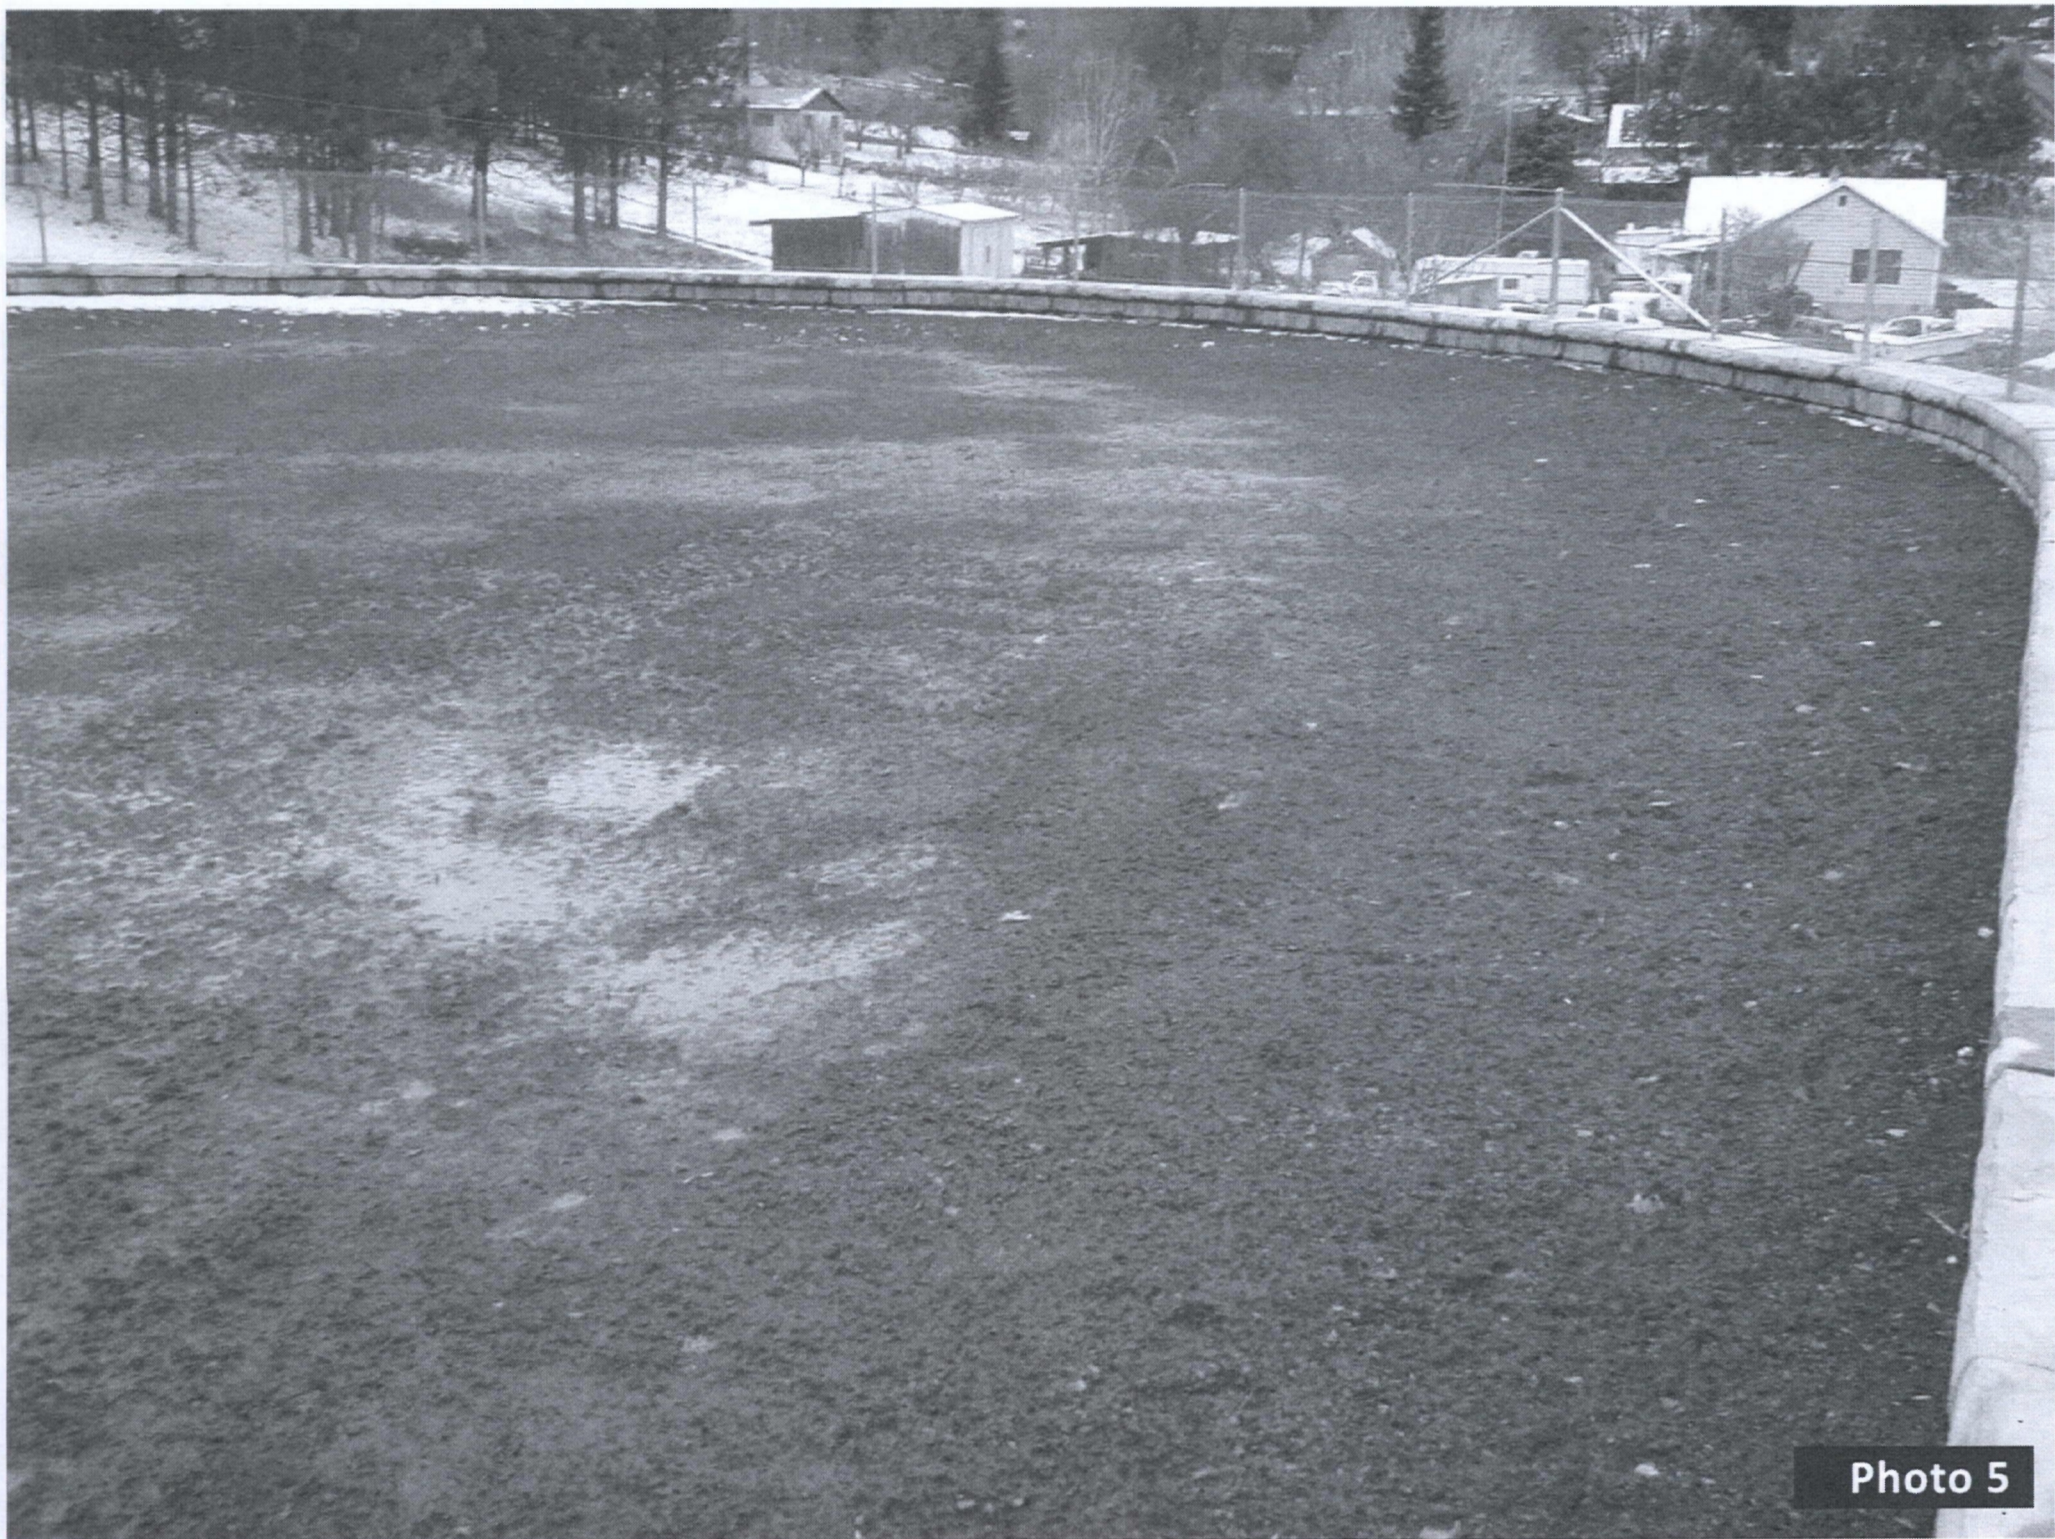
- During the site reconnaissance performed by Steve Hall and Mark Longtine on March 1, 2014, saturated conditions appeared to exist over the entire soil cover area, with shallow ponding over much of the area (see Photos 2, 3, 4, and 5).

The soil present over about half of the soil cover area (including grid points 1, 5, 6, 7, 8) contains abundant gravel and fines. The gradation of sand grain size is not known. The overall grain size distribution of the soil in this area is generally well-graded, with particle size ranging from gravel to clay. In general, well-graded soils have less porosity and lower permeability than poorly-graded soils. A given quantity of water will saturate a larger volume of low-porosity soil than high-porosity soil. A well-graded soil will tend to drain more slowly than a poorly-graded soil. Soil porosity and permeability are particularly important in cases where there is a barrier preventing migration of water, such as the plastic membrane preventing downward migration of water at the Orofino soil cover. Complete saturation of available porosity is evidenced by ponding across the cover area observed on March 1, 2014, and full-thickness saturation observed in test holes over about half the cover on March 21, 2014.

Saturated conditions may limit plant growth. It is possible that the saturated conditions that exist at the soil cover for part of the year are at least partially responsible for lack of vegetation. Lack of plant growth in turn limits transpiration, which, if plants were present, would reduce the soil water content. It is possible that, if vegetation were to become established on the soil cap during a period of favorable conditions, that the plants would subsequently support evapotranspiration at rates adequate to limit saturated conditions in the future.

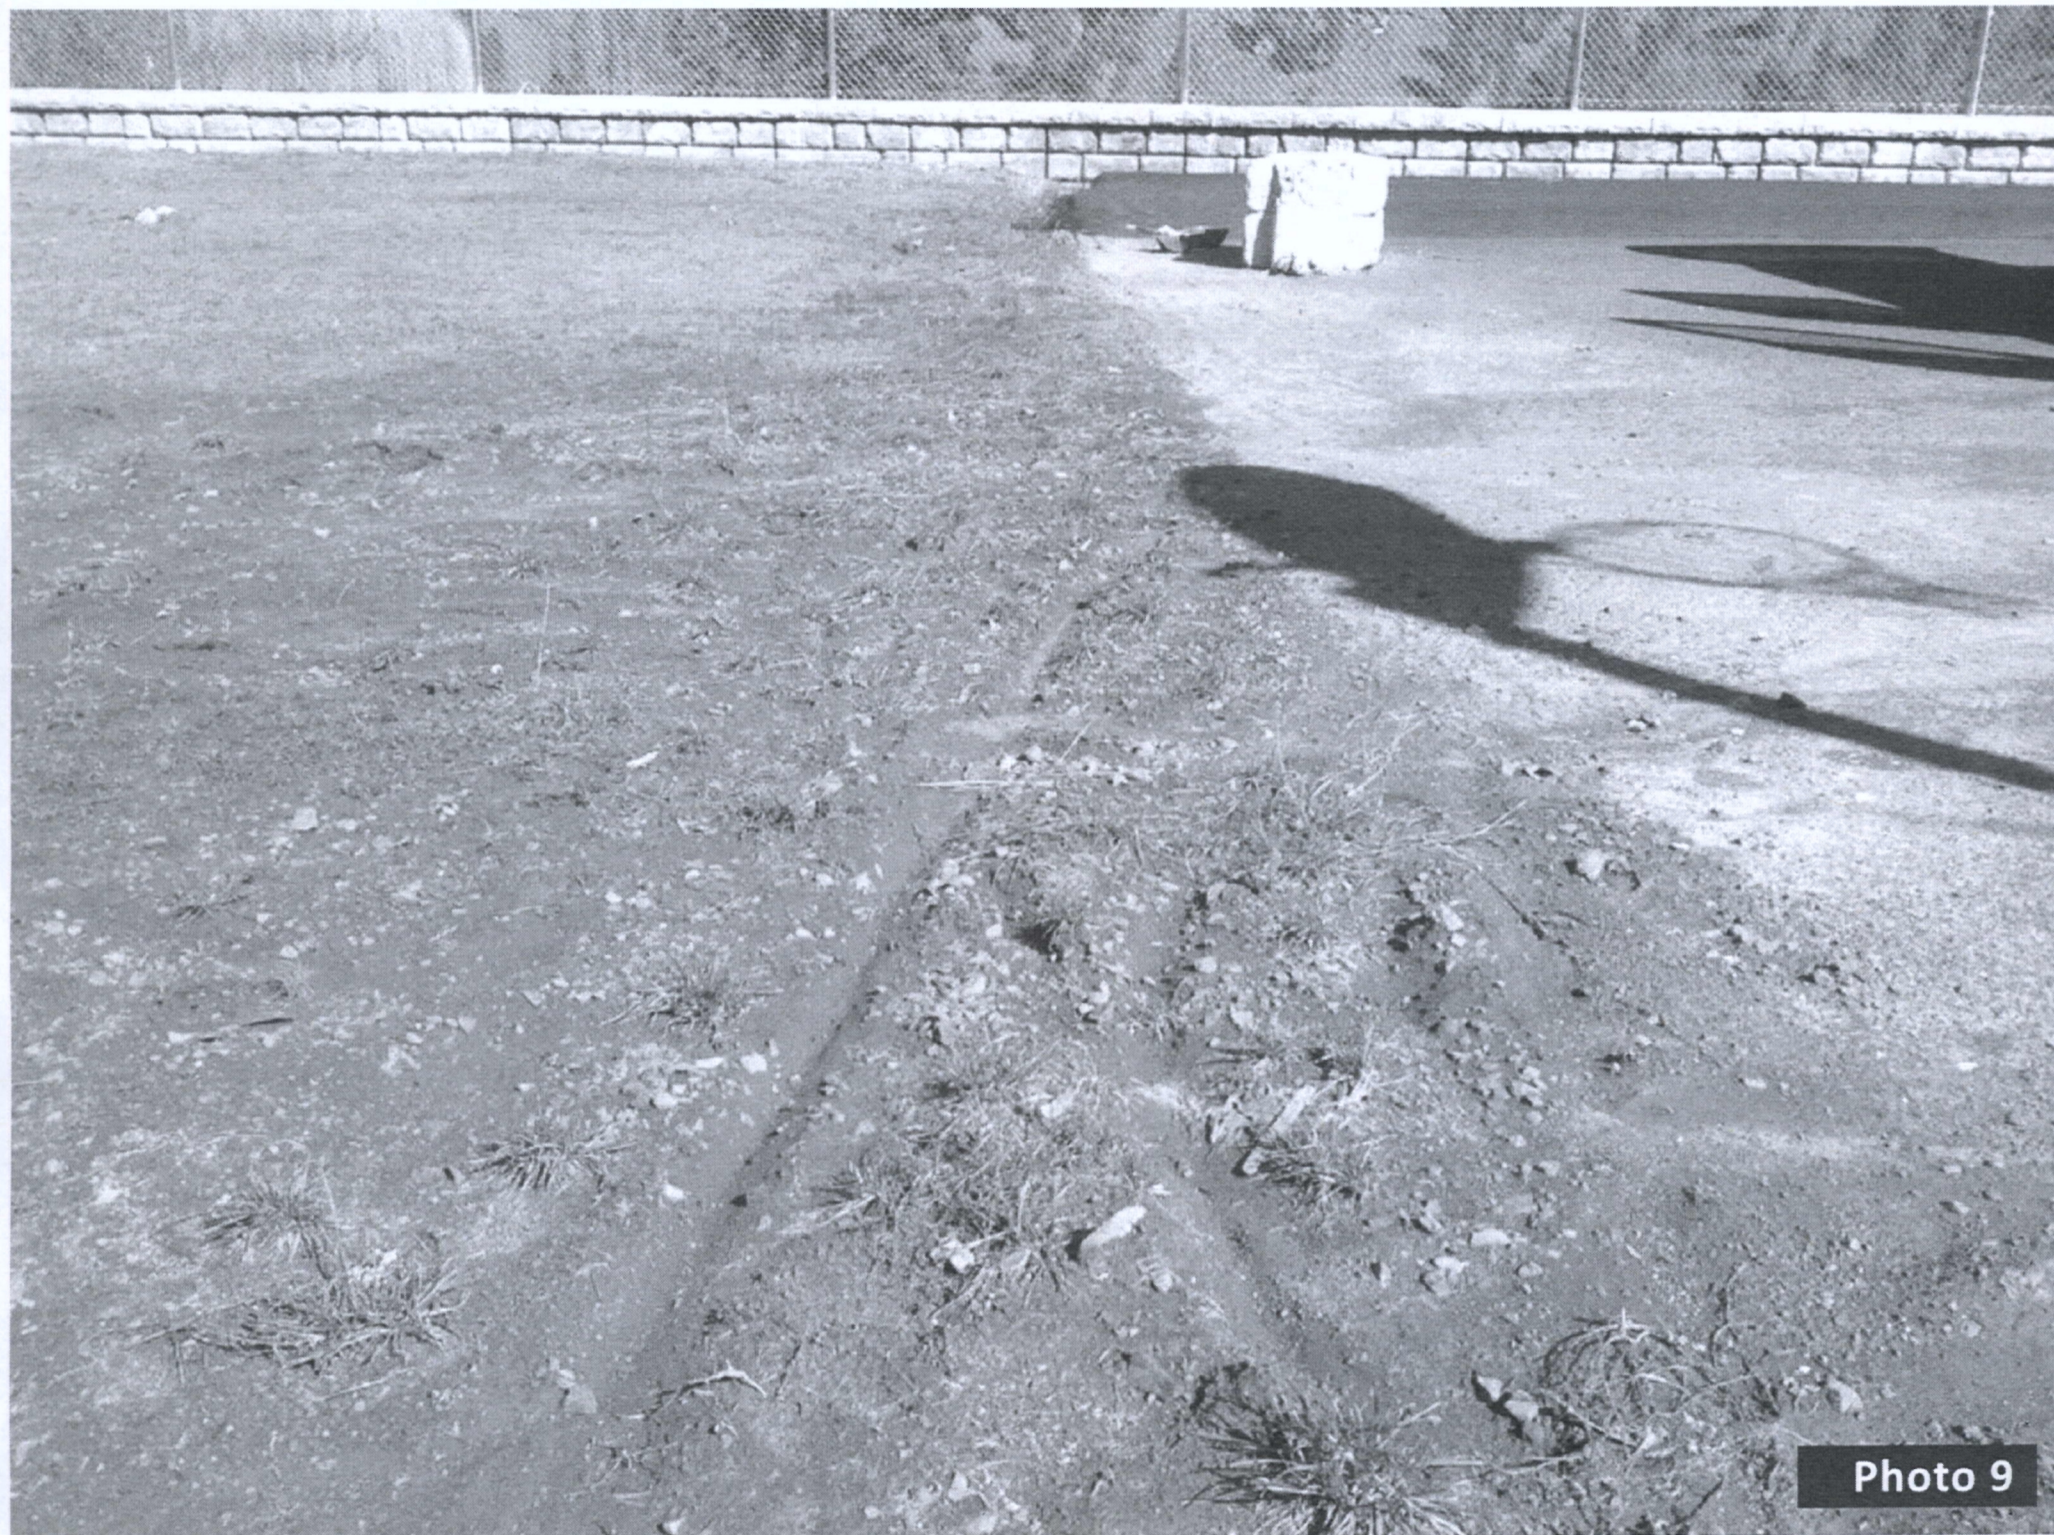
- There was some vegetation on the soil surface locally, including small sprouts of grass, moss, and thick patches of clover-like plants up to several feet across (see Photos 7, 8, 9, and 10).
- Other than the concentration of gravel at the surface, the grain size distribution and soil color were generally consistent from the top to the bottom of each test hole. Grain size distribution is discussed further below.

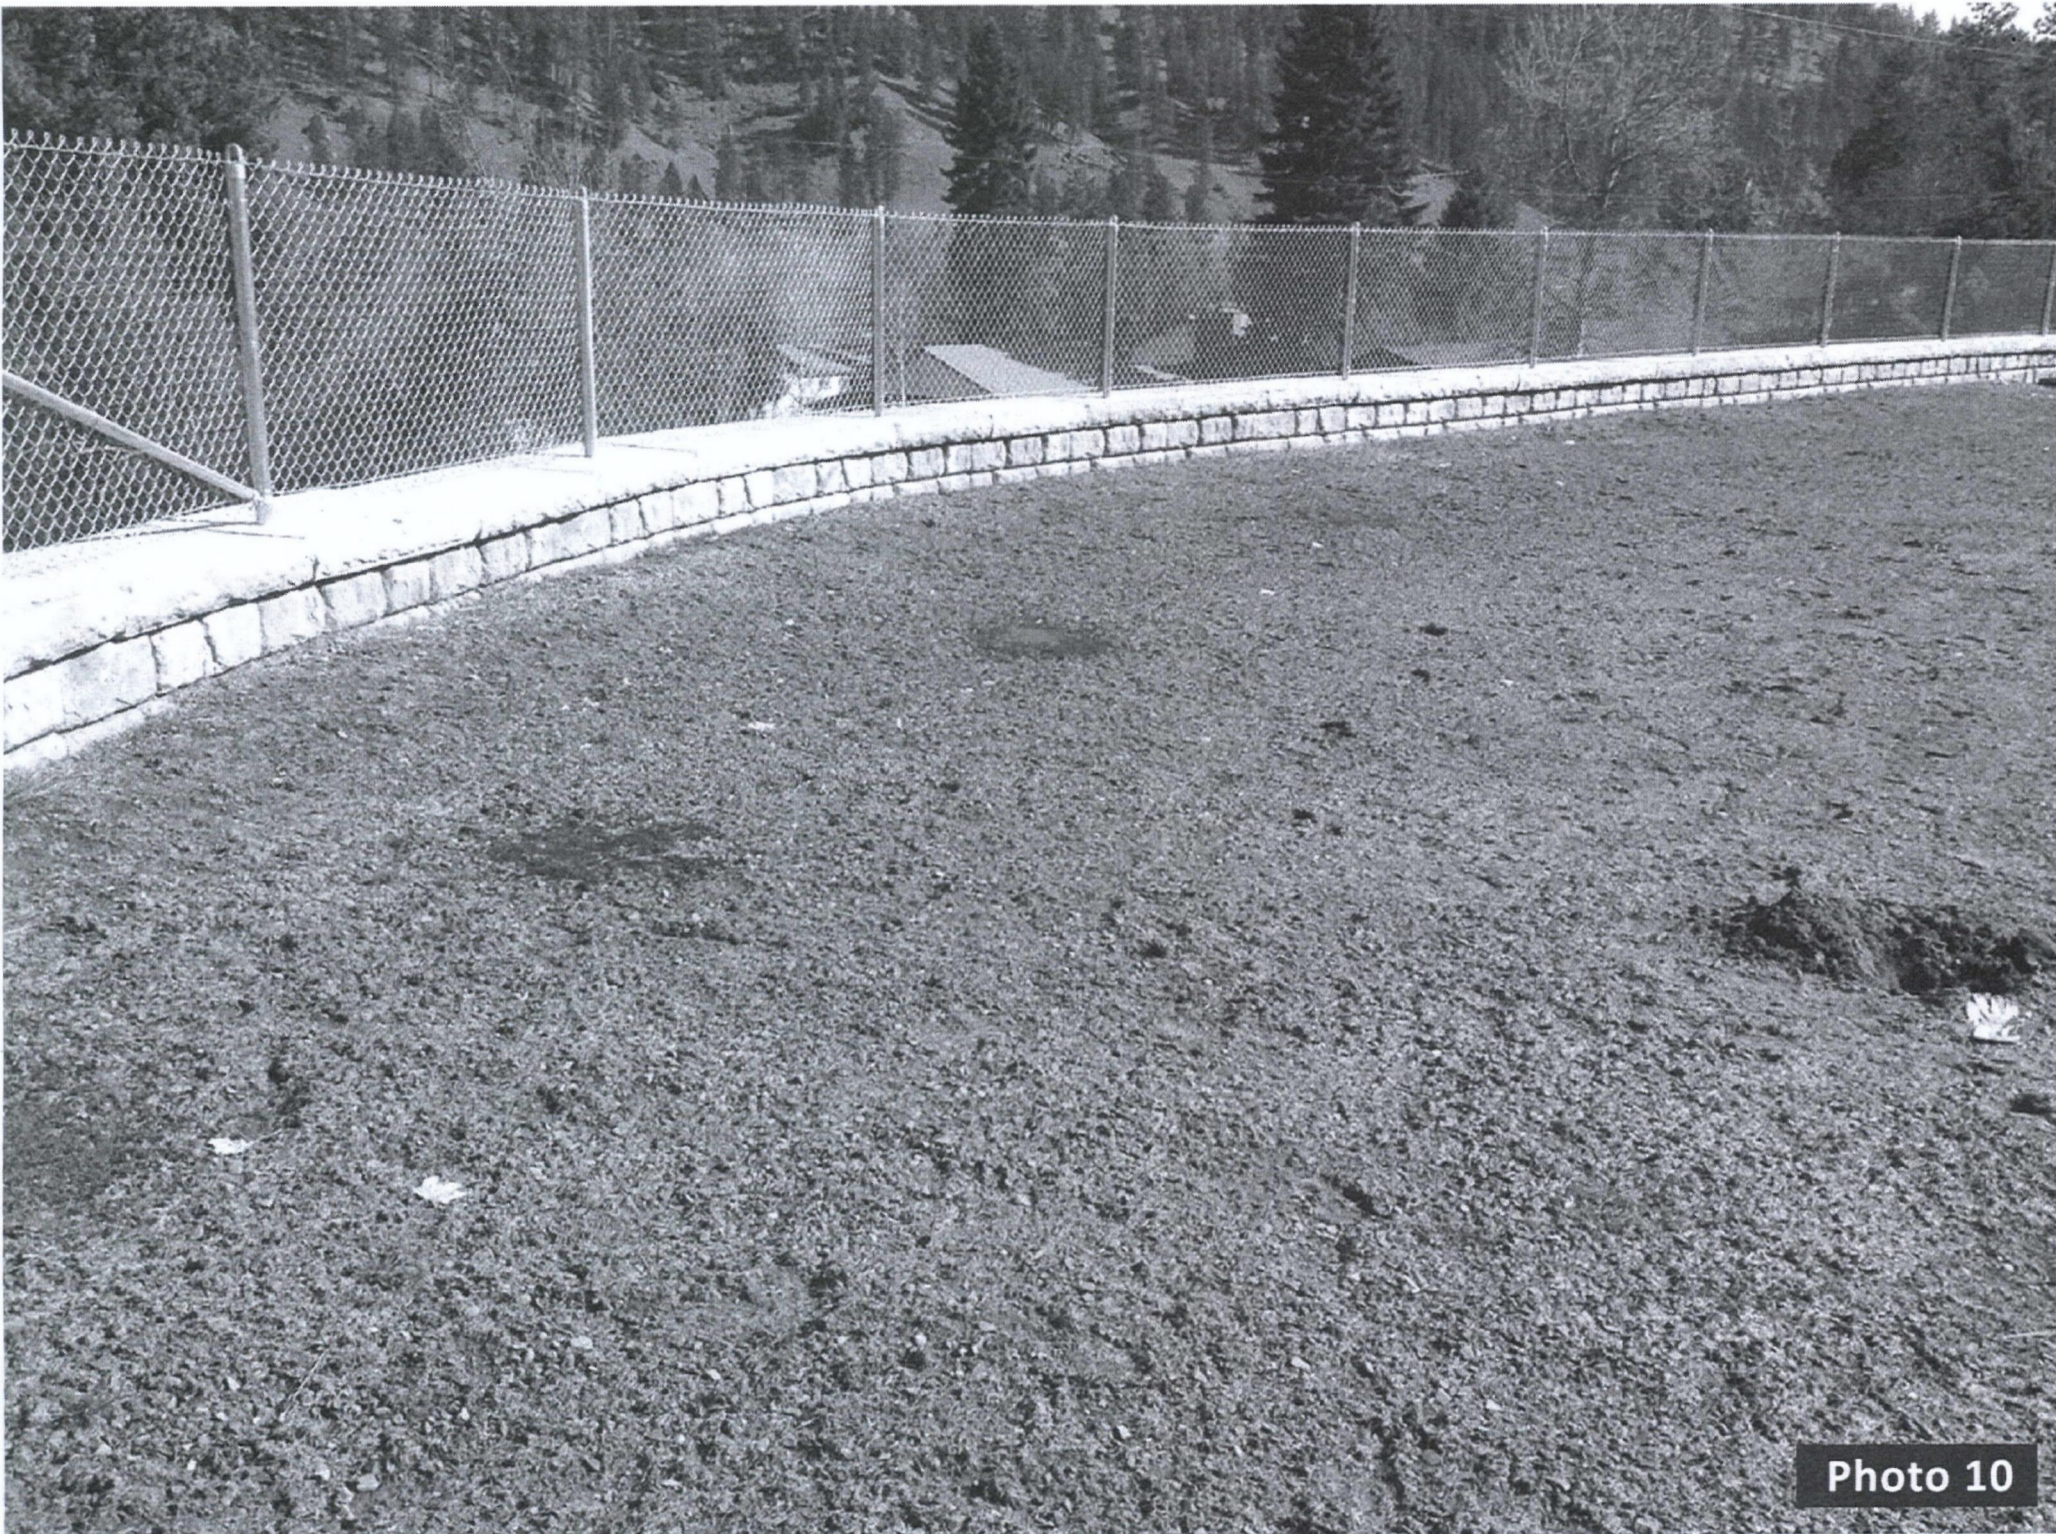
Photo 10

Pastor Hale Anderson informed Mark Longtine during the March 21, 2014 site visit that last summer he seeded the area between the drywell and the asphalt pavement because that area is typically wet and children often ride their bikes through the mud. He reportedly applied about ten pounds of seed. Some grass is growing in small patches in this area presently (see Photo 10).
